Kids Creek Subwatershed Action Plan

The Watershed Center Grand Traverse Bay

June 2013

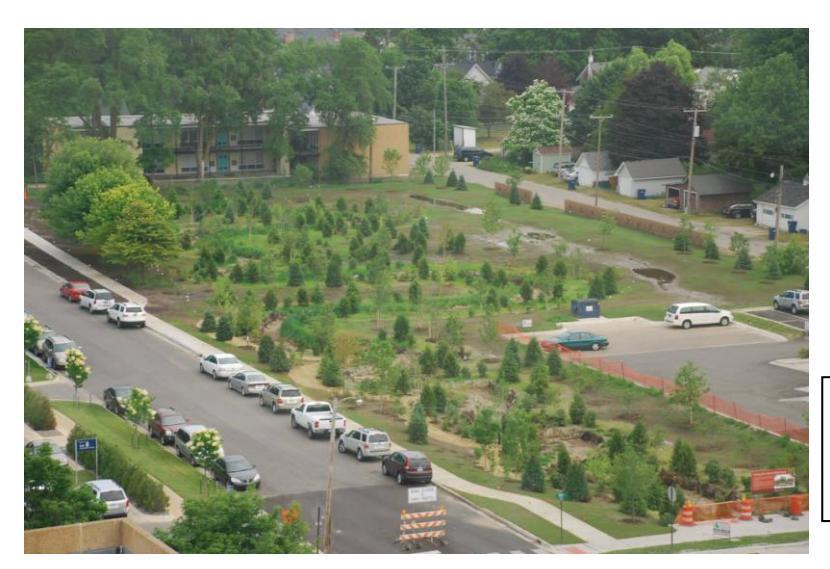
Birds-eye view of daylighting restoration project on Tributary A of Kids Creek on MMC Campus Photo credit: Denise Baker

Current efforts are already underway to relocate and daylight a portion of Tributary A that was either in channelized ditches or underground. The daylighting project is on Munson Medical Center's (MMC's) campus and will remove 900 feet of underground culverts and channelized

ditches and replace it with over 1,200 feet of new meandering stream channel. This same project removed 72,000 ft² of impervious surfaces.

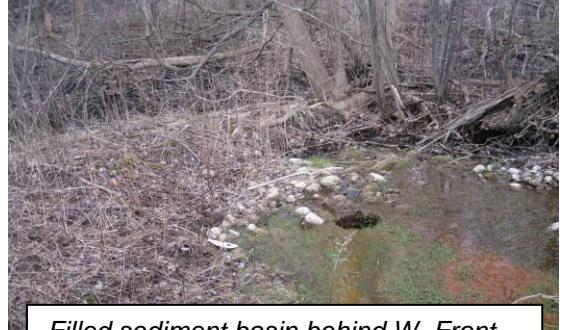
Site 1A: Parking Lot Adjacent to West Front Primary Care

Proposed BMP Course: Reconstruct sediment forebays behind office complex. Purpose is to address snow removal and sediment management practices. The existing detention basins for stormwater runoff from the office complex are completely filled with sediment (see accompanying photo) and no

Filled sediment basin behind W. Front Primary Care office

longer provides flood control or water quality benefits. Restoring and enhancing the existing basins will allow them to be retrofitted to capture or infiltrate stormwater while also providing water quality benefits. These retrofitted BMPs will require proper maintenance to remove sediment buildup to maintain their effectiveness.

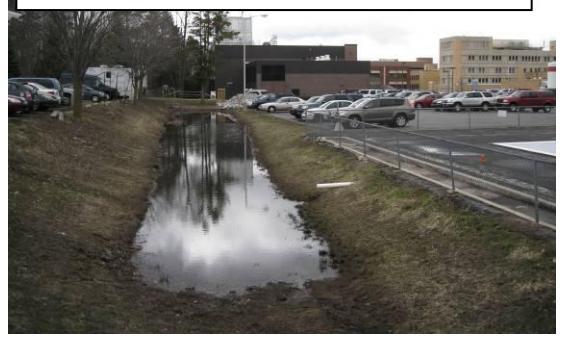
One of the existing detention basins near the MMC Helipad (on right)

landing (south and north) and reconstruct outlet to encourage infiltration, provide for sediment capture and mitigate peak flows. This

site can reduce peak flows and sediment from several parking lots that directly drain to them. By modifying the existing outlet structures greater retention of sediment and flows can be achieved. Detention of flows will have to be carefully assessed so as not to induce localized flooding of Medical Campus Drive and Red Drive (farther south).

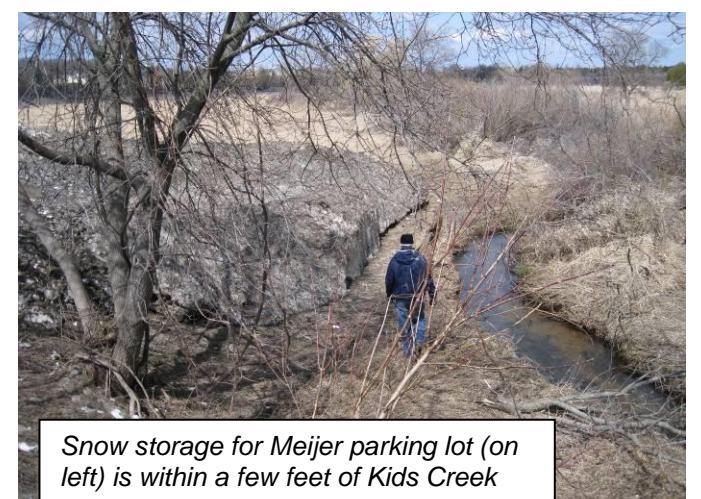
Creek. The Meijer store uses the area adjacent to Kids Creek for snow removal storage. This practice delivers sediment and trash to the creek

and the creek riparian area. Providing for an engineered snow storage area will allow Meijer to remove sediment and trash from the site and limit the quantity that is discharged to Kids Creek

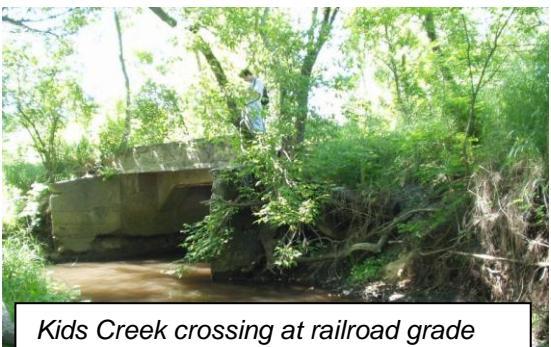
There is one severe road stream crossing site on Subbasin 2 located on an old railroad bed, now a heavily used foot trail. There is extreme erosion along the edges of the existing concrete bridge structure and it is

Kids Creek crossing at railroad grade near old Elmwood Ave

cracked and crumbling in places (see photo at right). The estimated cost to replace the bridge is between \$10,000-\$15,000 and it should be done soon. There is also a moderate-ranked crossing in Sub-basin 6 in the Kids Creek headwaters on Silver Lake Road. The estimated cost to fix is about \$25,000.

| Site Number | Sub- basin | Stream Name | Severity | Suggested BMP's/Comments | Estimated Cost Range | Link To On-Line Detailed Fact Sheet |
|---|---|---|---|---|--|---|
| S702 | 2 | Kids Creek | Severe | Replace with open bottom recreational bridge | 10,000- 15,000 | http://www.northernmichiganstreams.org/RSX_site_o.asp?sdbfid=1000 |
