Grand Traverse Bay Watershed Planning Project

Field Assessment of the Grand Traverse Bay Shoreline

**March 2003
The Watershed Center Grand Traverse Bay**

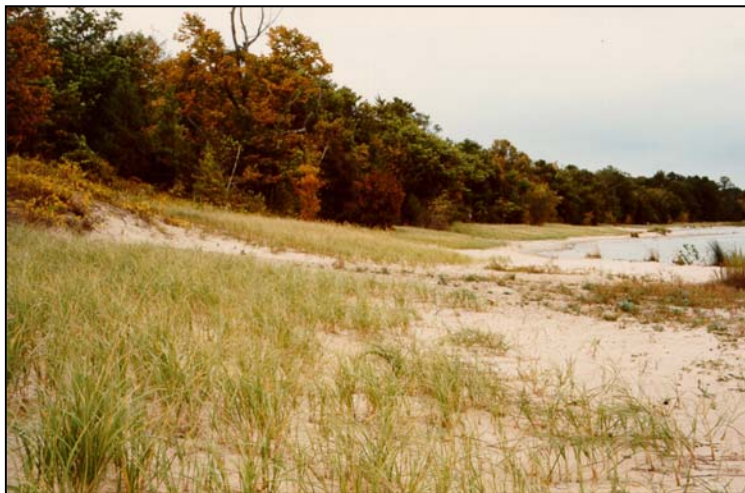
Example of Beach Dunes Along Old Mission Peninsula

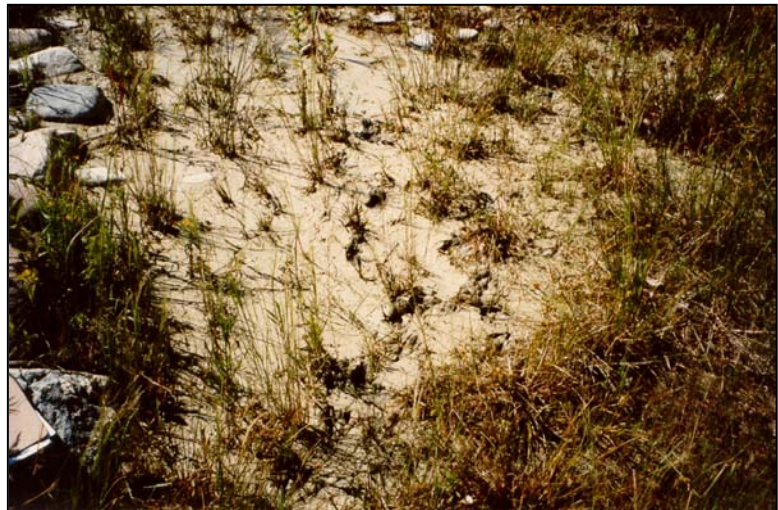
Example of a Clay/Silt Beach Area

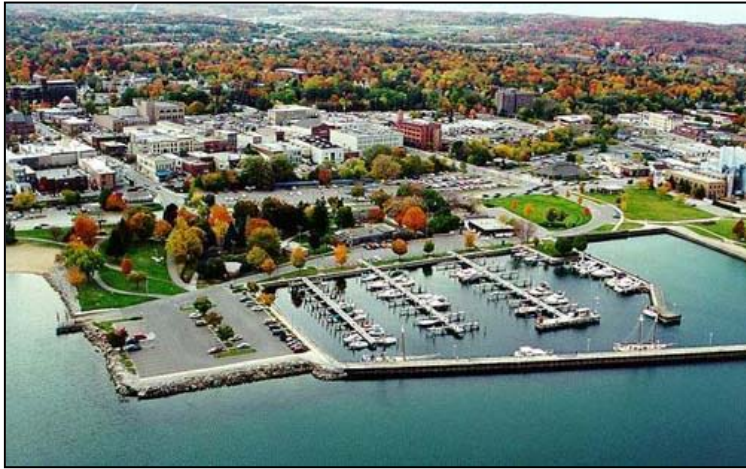
The Clinch Park Marina and Open Space (Figure 3, Points G & H) are located to the west of the Clinch Park public beach area. The shoreline along this area has significant shore hardening with concrete and large rip-rap. The Boardman River (Figure 3, Point I) empties into the bay just east of Clinch Park. The dry beach and nearshore are gradual in gradient and are

Clinch Park Marina – aerial shot

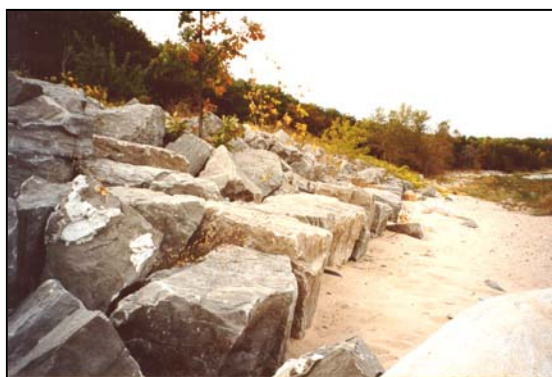
Example of shore hardening using large rock rip-rap.

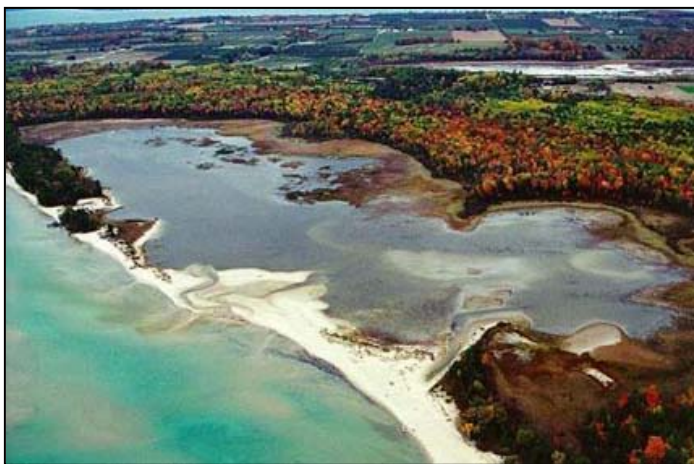
Ptobego Creek and Pond Natural Area – aerial shot

natural Lake Michigan shoreline. It is a wide, gradual, sandy, dry beach with both beach and upland dunes. The nearshore is a mix of sand and stones. Ptobego Creek (Figure 4, Point I) empties into the bay here.

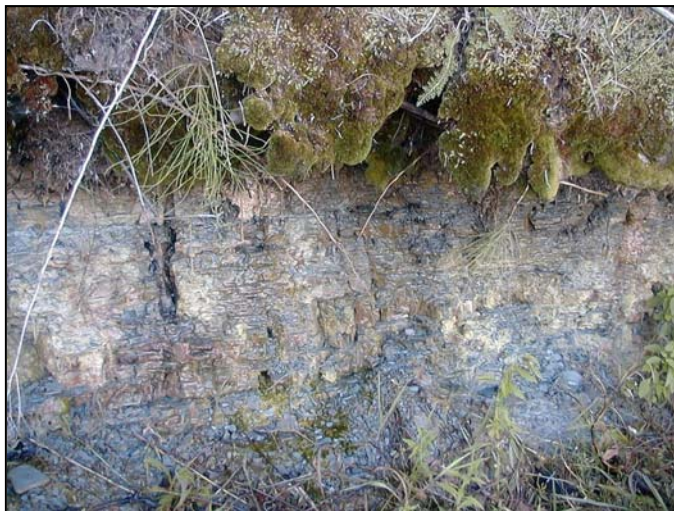
Close-Up of Antrim (Blue) Shale Bluff

North of Eastport to Norwood the beach narrows and becomes more stones than sand. The most unique observations of the whole shoreline inventory are the areas of exposed Antrim shale. The blue shale bluffs, the shale fragments on the beach and the layers of blue shale extending into the lake substrate were very impressive.

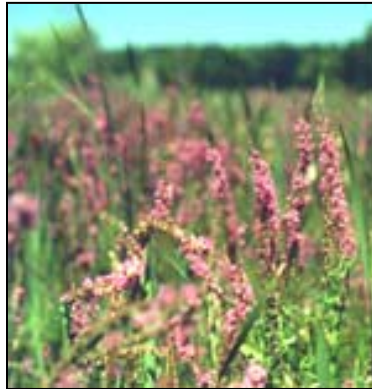
Purple Loosestrife

Exotic species observed during the shoreline inventory included purple loosestrife and zebra mussels. Purple loosestrife grows extensively along the shoreline. It mostly occurs where it is sheltered from direct wave action and on stony, rocky substrate. It may also occur on sandy substrate, although not as common, as demonstrated at the foot of West Bay and along the Boardman River. With relatively low lake levels, purple loosestrife has taken hold in some of the emergent wetland areas.

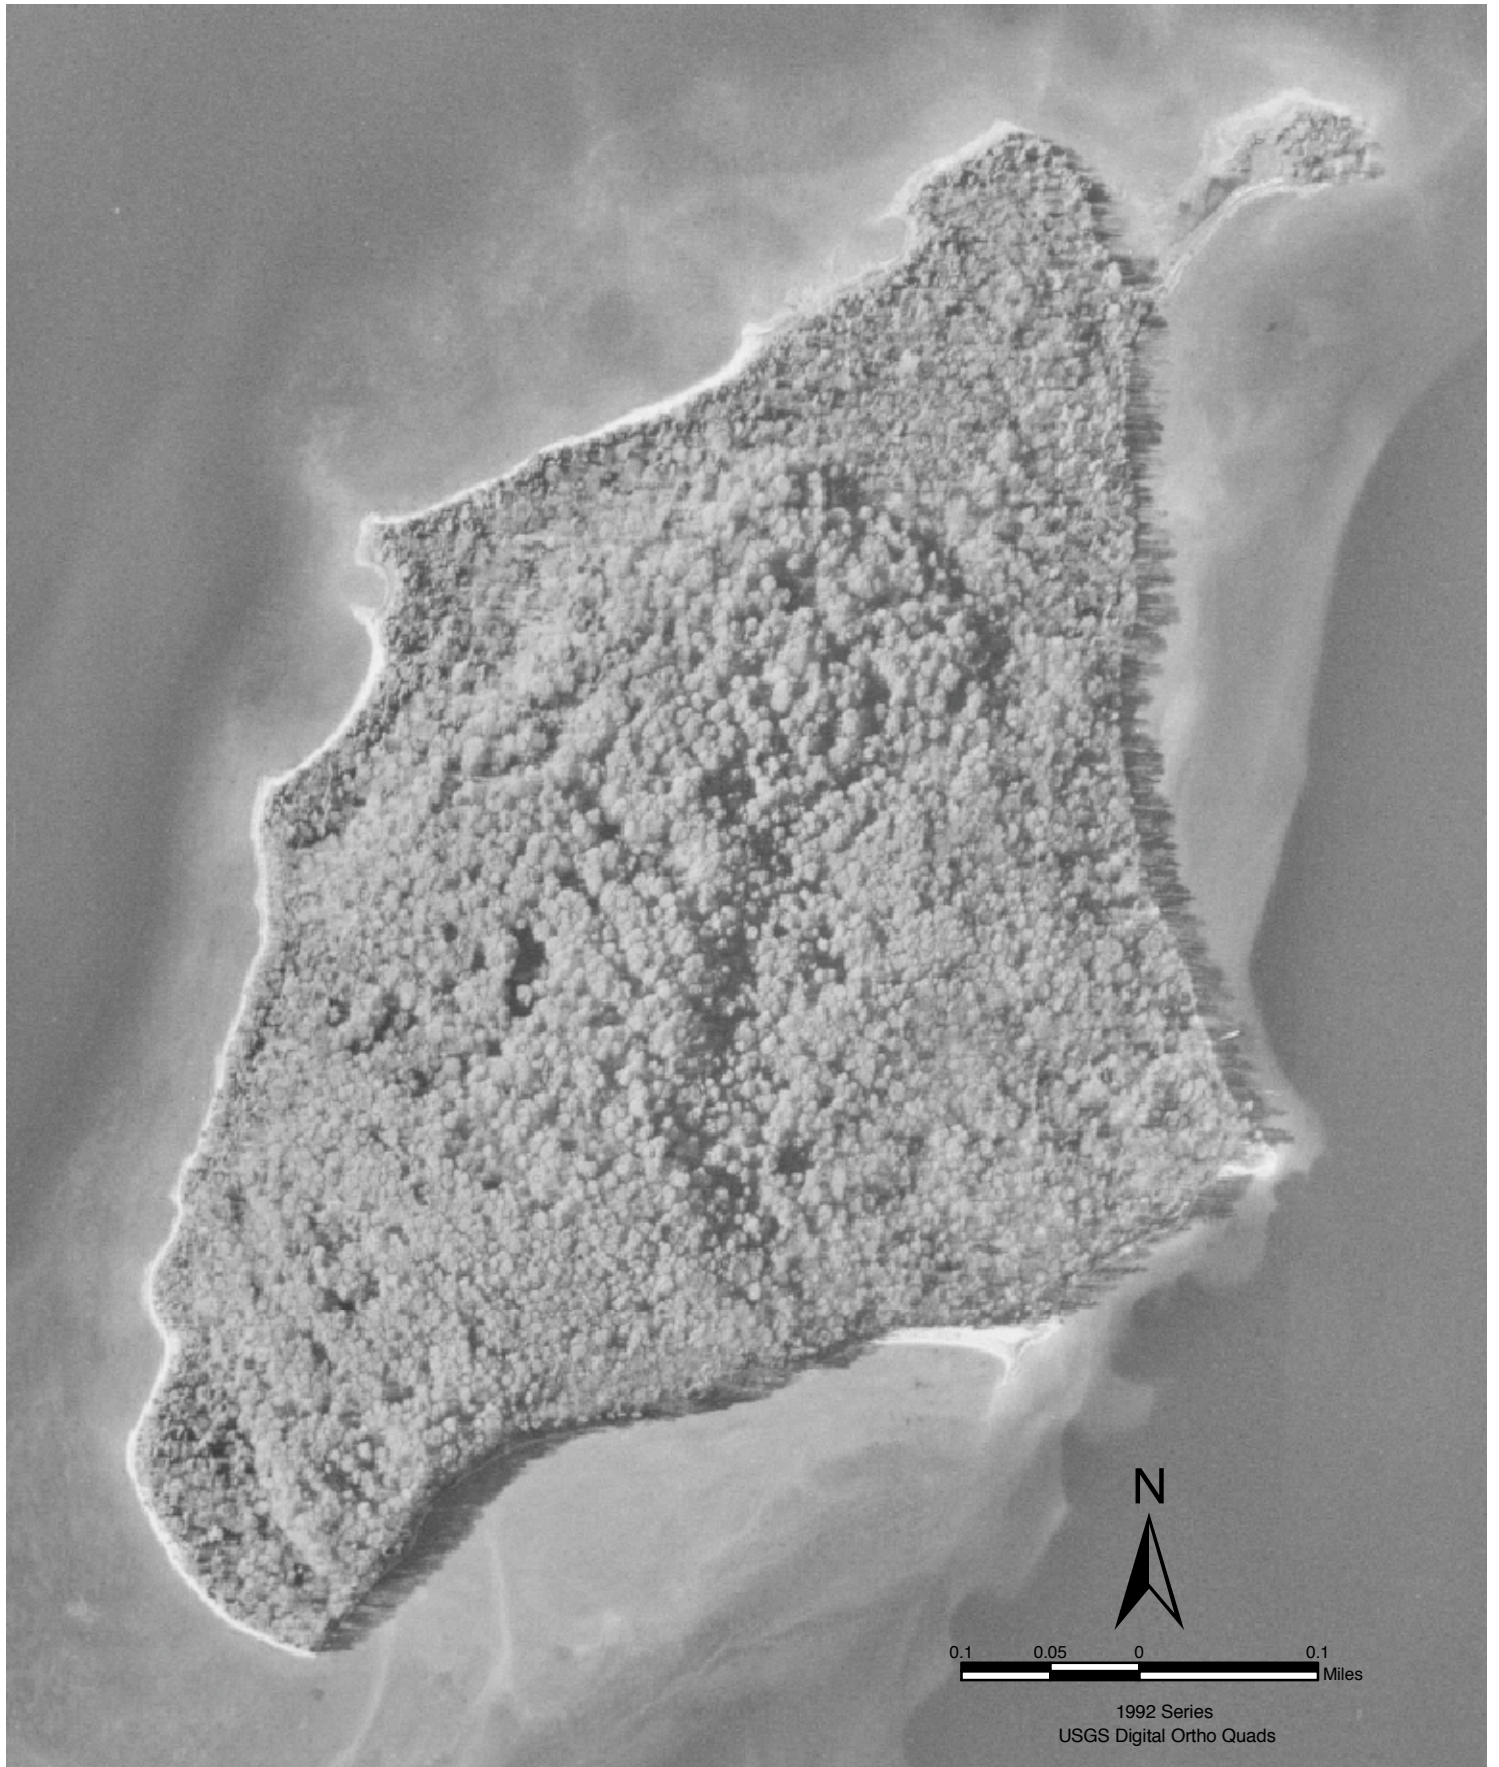
Figure 6

The last segment of the shoreline inventoried was Power Island in June 2003. Power Island, located in the central portion of West Grand Traverse Bay, is a public preserve owned and operated by Grand Traverse County. The shoreline of Power Island is a natural shoreline, which includes examples of many of the natural shore types surrounding Grand Traverse Bay.

From the public dock, located on the southeast side of the island, south to the middle of the southern shore, the nearshore is a mixture of sand and stones, as is the beach. The upland is natural with public picnic areas. The western end of the south shore has a mixture of stones and clay on the nearshore and beach areas with a 20-40 foot bluff to the upland. The western shoreline exhibits large rocks and stones both in the nearshore and on the beach. A 20-foot bluff runs above the beach for about 2/3 of the length of the western shoreline.

The north 1/3 of the island is low and flat with upland wetlands. These wetlands output groundwater into the bay in small streams and seeps. Some ephemeral ponds exist on the beach and emergent wetlands are found along most of this shoreline.

Bassett Island is connected to Power Island at the northeast tip. The beach and nearshore in this area is low, flat, and gradual with a mix of clay and stones. Except for the eastern shore near the public dock the nearshore is shallow shoal water. Near the public dock the nearshore drops off to deep water close to shore.
