Shanty Creek Area - Stormwater Action Plan

Project Summary

Findings/Recommendations: Shanty Creek Resort and Buildings

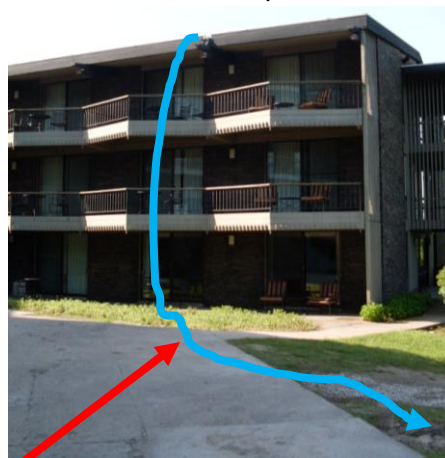
Current Runoff Path and Resulting Erosion

- *Findings:* Runoff from the roof goes into raised bed gardens, or into a drain that goes into a dry well
- *Recommendations:* Excavate beds and plant with native vegetation to help capture stormwater and reduce erosion

****Noted erosion problems are due to stormwater runoff but have no affect on surface water quality***

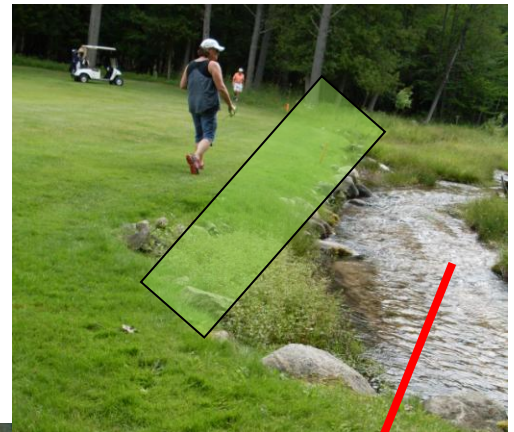
- Creek runs through The Legend golf course green on hole #8 and has mowed lawn to the banks of the creek

- Install a greenbelt buffer along this stretch of the creek, suggested depth of 50-75 feet, or eliminate mowing

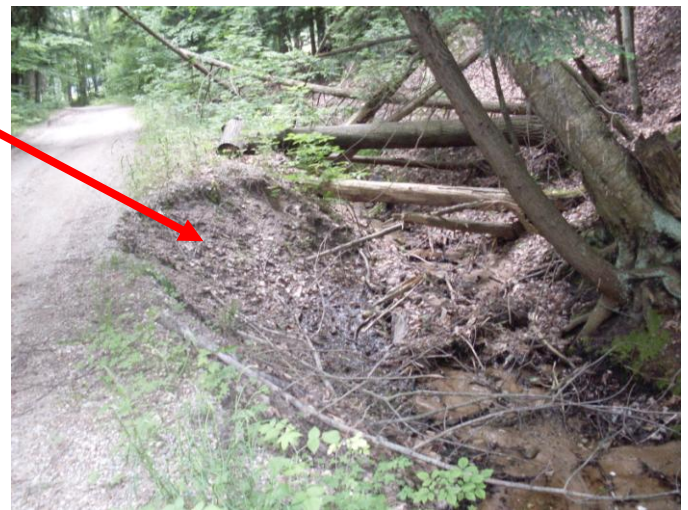
- Multiple sites along Shanty Creek and its feeder creeks receive runoff from gravel roads adjacent to the creek (see photo at right)

- Install bio-detention swales and speed bumps to help direct runoff into swales
- Install large rip-rap to help reduce erosion and disperse water energy

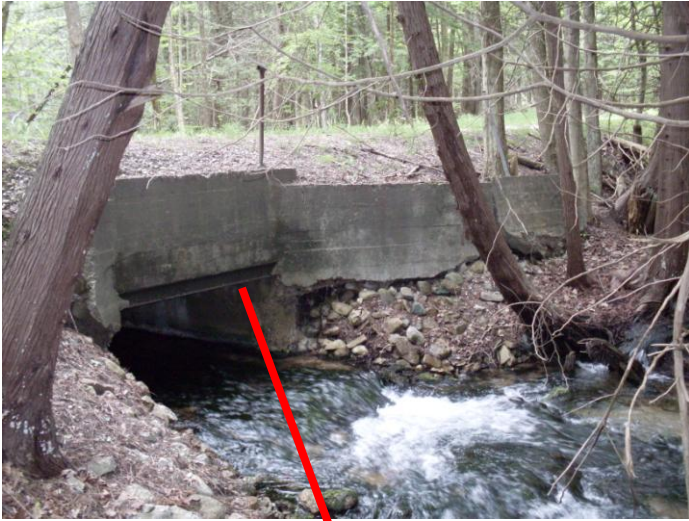
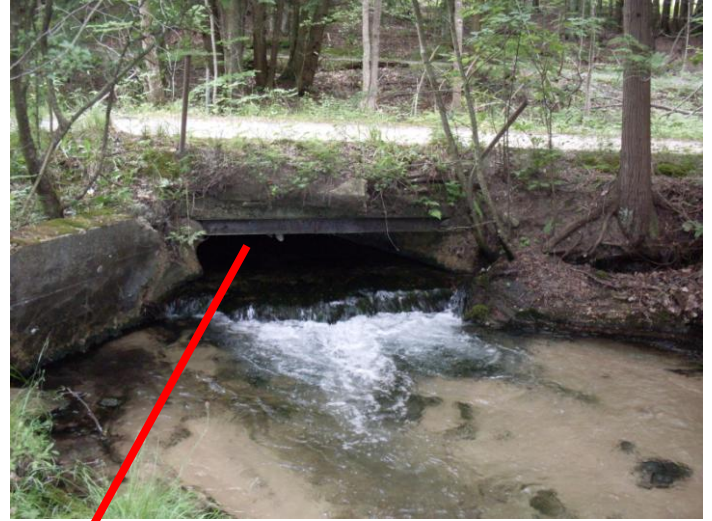
- Road-Stream Crossings - (unnamed maintenance road along Shanty Creek)
 - ~Findings:
 - Gravel road bridges cross Shanty Creek at two locations that constrict stream flow and have erosion around the structures (see photos below)
 - ~Recommendations:
 - Remove current bridges and install open bottom bridge structures
 - Stabilize stream banks with woody debris, rip-rap and native plants
 - On either side of the bridges, install large rocks and native plants to help decrease erosion from road runoff

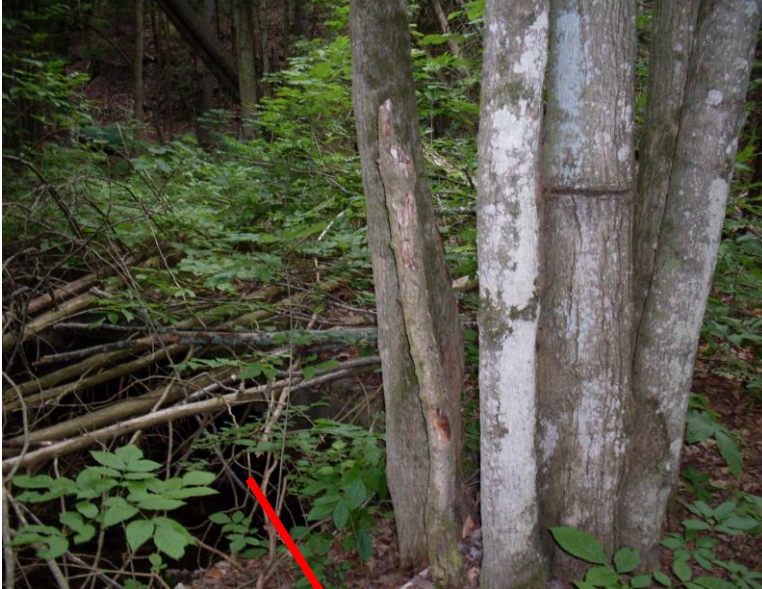
- Old Road Crossing Structure - (Forest Trail/Creekside Drive)
 - ~Findings:
 - Structure with two large concrete abutments constricting flow of the creek (see photo below)
 - ~Recommendations:
 - Remove structure
 - Stabilize streambank with woody debris and plantings

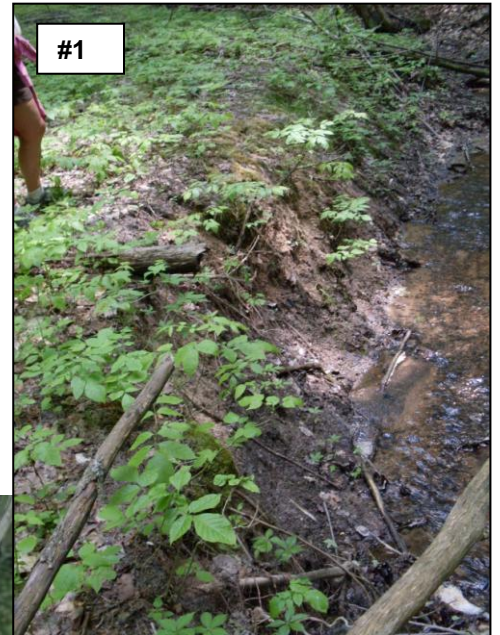
- Multiple sites along Maury Creek have erosion most likely due to flashiness of creek and increased flow during rain events (see example at right, #1 on map)
- GPS: 44.952165, -85.192735

- Where possible install natural erosion control techniques to stabilize soil (i.e. native plants, coir logs, etc.)
- Where necessary, install large rip-rap to help reduce erosion and disperse water energy

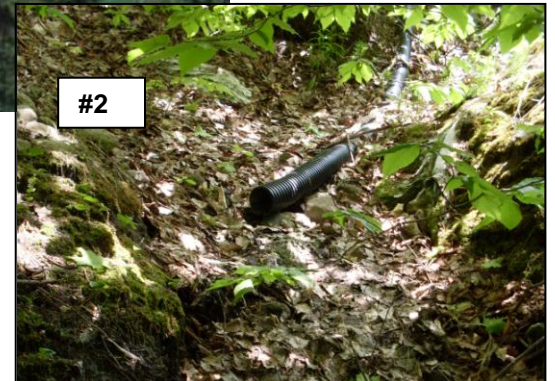
- Single tile drain from golf course exits approx. 100yds from Maury Creek, creating pathway of erosion (see photo at right, #2 on map above)
- GPS: 44.952028, -85.191774

- Install large rip-rap to help reduce erosion and disperse water energy
- Work with private homeowners' associations up the slope to slow water and capture it in bioswales or rain gardens.

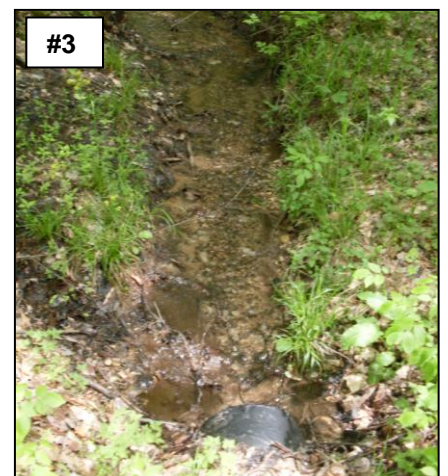
- Creek constricted to a pipe for access road (see photo at right, #3 on map above)
- GPS: 44.952178, -85.192683

- Remove culvert, Construct an open bottom bridge structure and place rip-rap and plantings around it to decrease erosion and stabilize soils

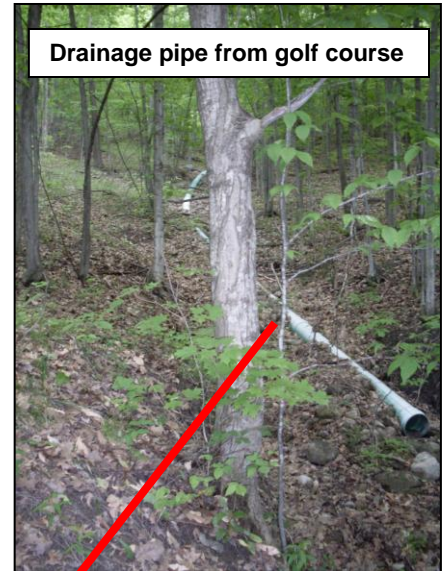
- Stormwater from drainage tiles on the golf course are piped to a location down a hillside (see photo at right) on private property. (5801 S. M88 Hwy)
- There is heavy erosion where the pipe outlets and creates an unnamed stream in conjunction with natural groundwater seeps. Creek eventually crosses M-88.
- Pipe outlet at GPS: 44.949084, -85.196521

- Install large rip-rap at drain outlet to help reduce erosion and disperse water energy
- Install plantings to help stabilize the soil
- Replace existing pipes with infiltration trenched pipes allowing some of the stormwater to percolate into the soil and infiltrate naturally along the way
